Full Scale Test of a SSP 34m box girder 1. Data report

Publication date:
2008

This report contains the complete test data for the final test, in which the box girder was loaded until failure. A comprehensive description of the test setup is given. This report deals only with tests and results. There are no conclusions on the data in this report, but references are given to publications, where the data are used and compared with FEM etc.

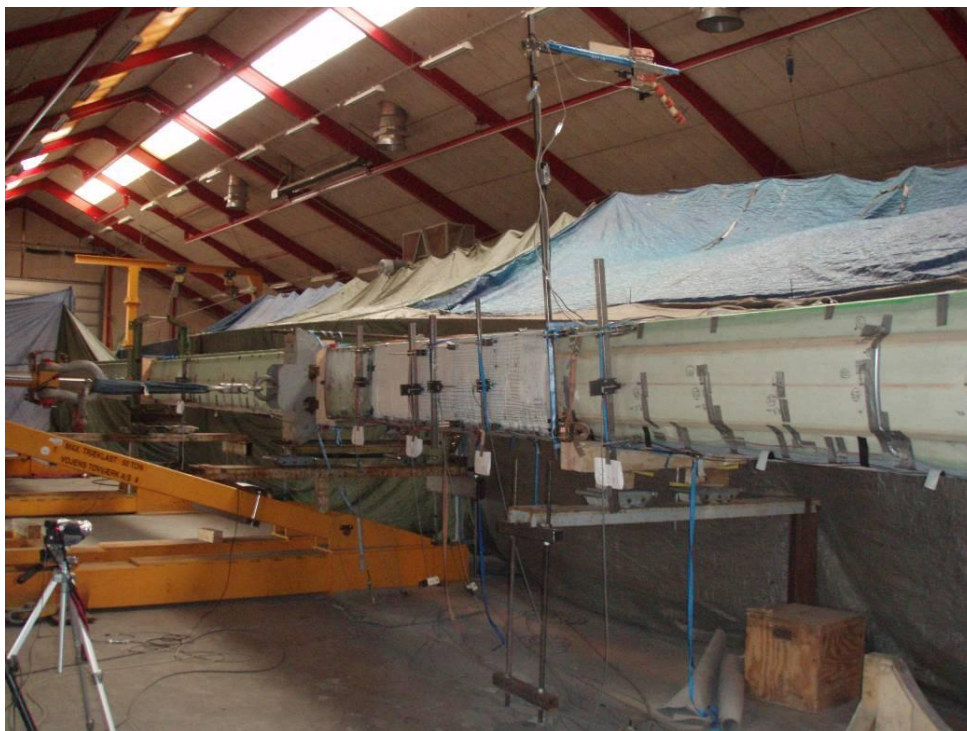
Figure 4. Box girder no 1 ready to be tested, view of the compression side.

The box girder mounted in the test rig is presented in Figure 4 and Figure 5. A previous full-scale test of a complete 34m wind turbine blade from SSP- Technology (box girder including the aerodynamic shells) has shown that it was able to withstand the required loads defined by the Authorities. After the box girder had passed all static and dynamic tests required by the classifications it was tested to failure. This has shown that the shear webs were the most critical part of the blade and therefore they have been reinforced in these new tests. These reinforcements are shown in Figure 1. Due to them, other failure mechanisms could be studied, see [4] and [8].

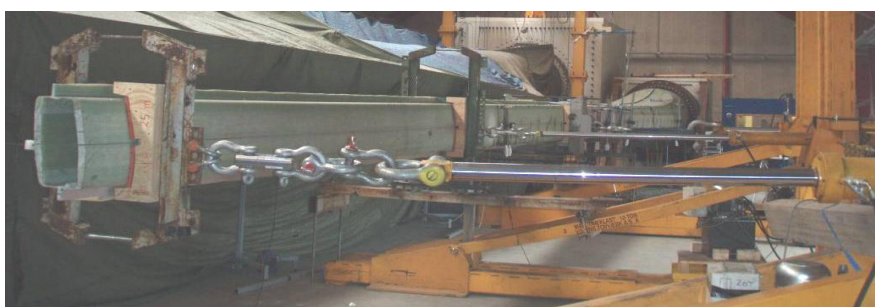
Figure 5. The shortened box girder mounted in the test rig.

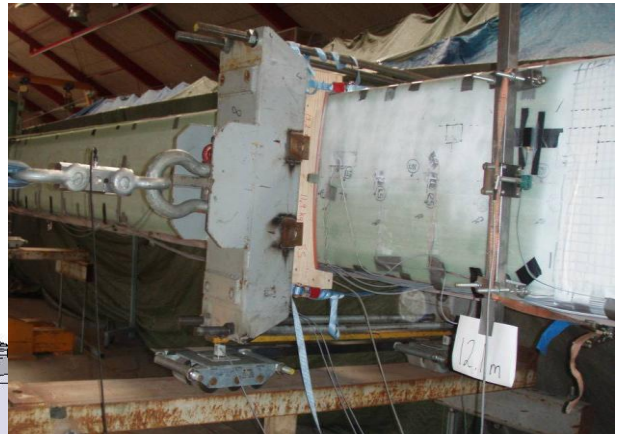
Fig. 8b

Figure 8. Fig. a: Sketch of roller-skate support; Fig. b: Roller-skate support at 13.2m

Three simple supports mounted with roller-skates were used to eliminate twisting and distortion of the box girder during the flapwise test, see Figure 8. They were placed at distance of 9m, 13.2m and 19m from the root, Figure 9.

In the trial tests only section 13.2 and 19m were supported. Due to experience from the trial tests an extra support at 9m was found necessary.

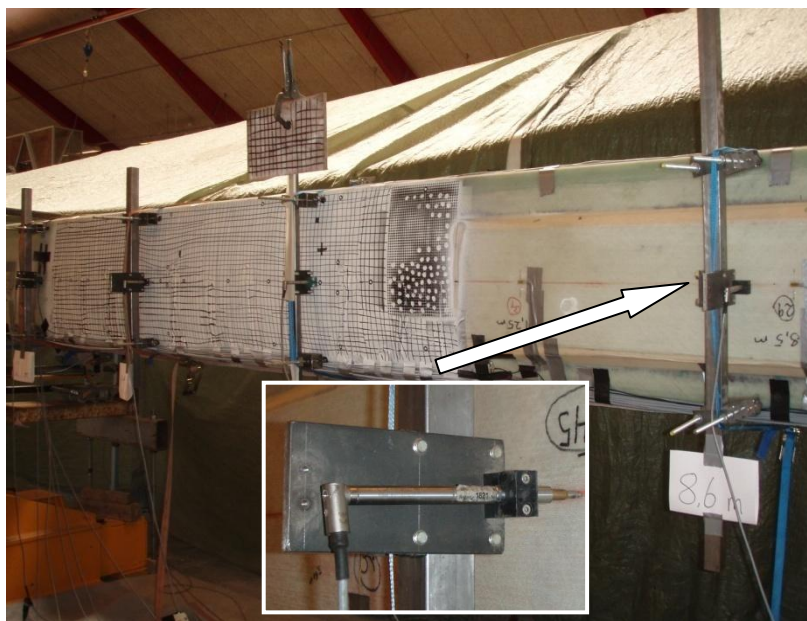
Figure 18. LT-LVDT equipment on the outer compression side of the box girder.

On the outer side of the box girder, seven LT-LVDTs were mounted to measure local deflections of the compression cap centreline, see Figure 18.

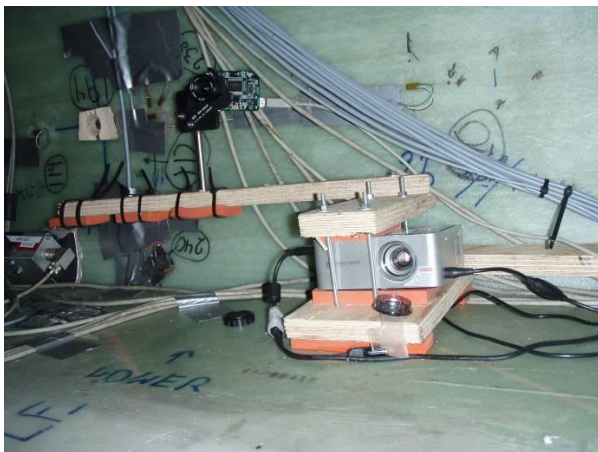
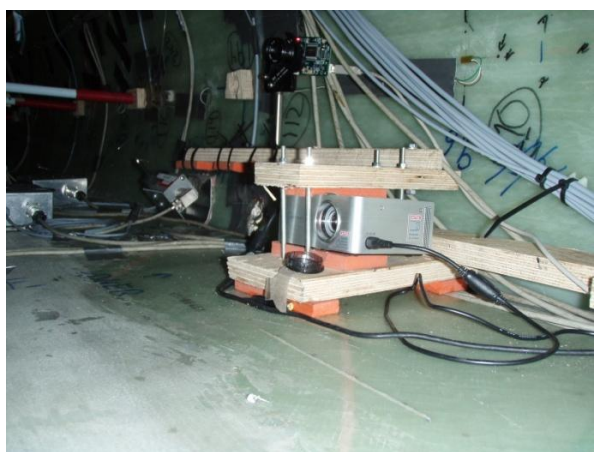
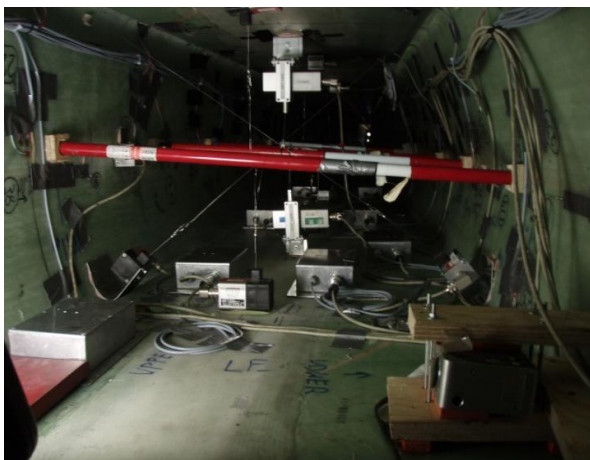
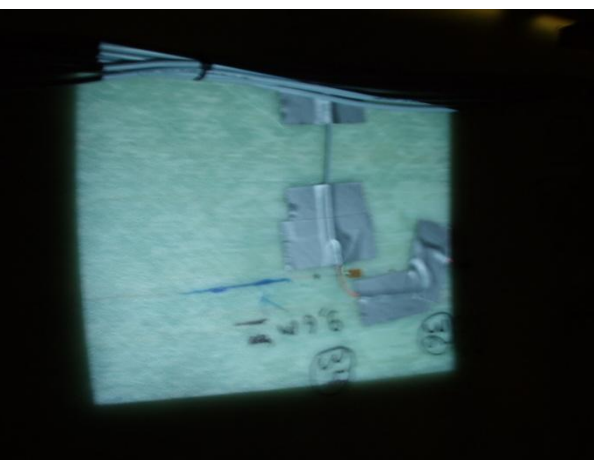
Figure 26. Pictures a-c: The fringe projection system seen from the front; d: The measuring area inside the compression cap at 9.5m

The measurements on the compression cap were performed from the inside the box girder. For this measurement the fringe projection equipment was placed inside the box girder, see Figure 25.

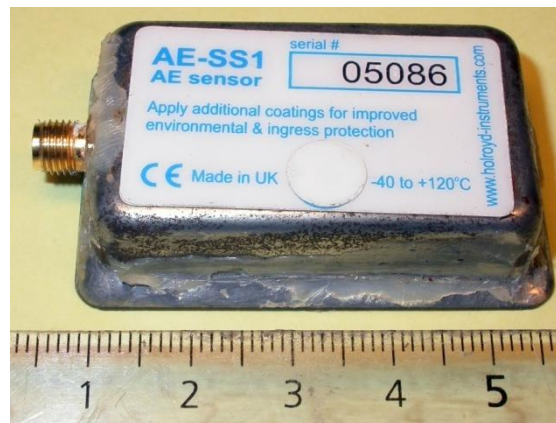
Figure 31. Acoustic emission sensors used Holroyd instrument AE- SS1

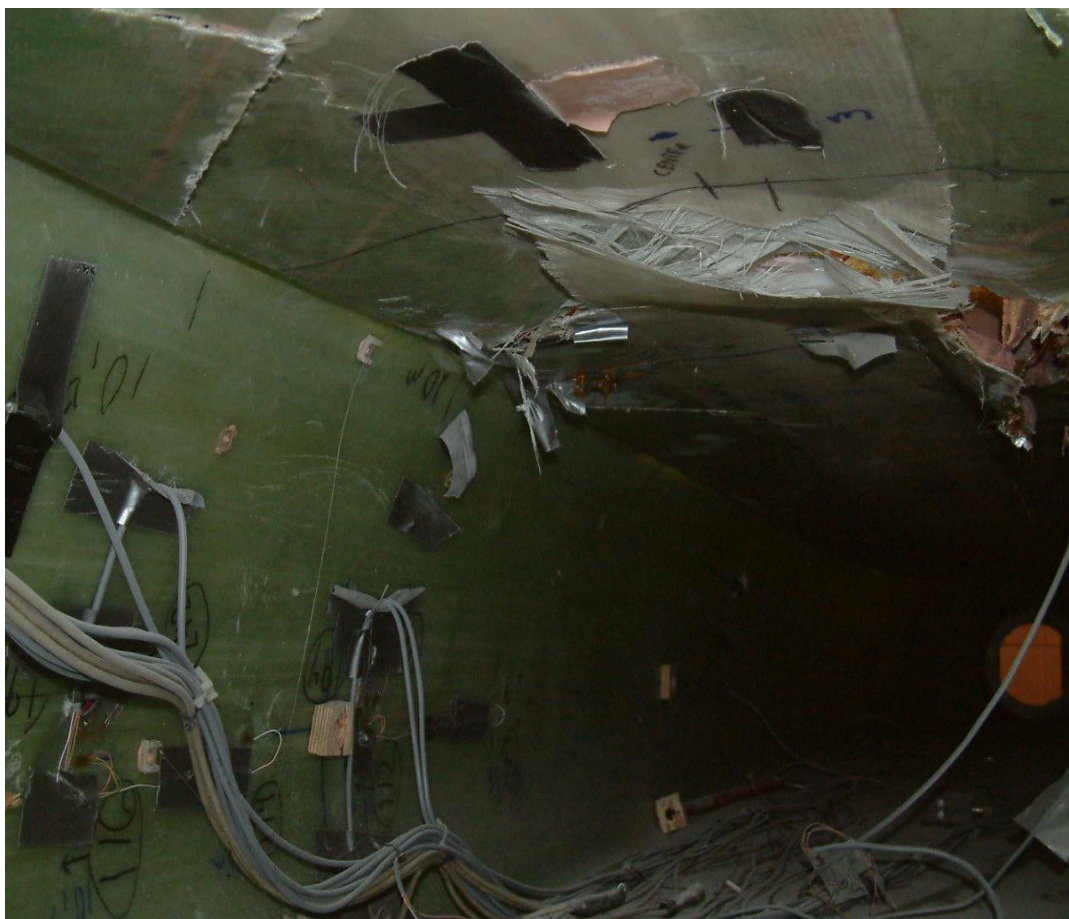
Figure 42. Inside the box girder.

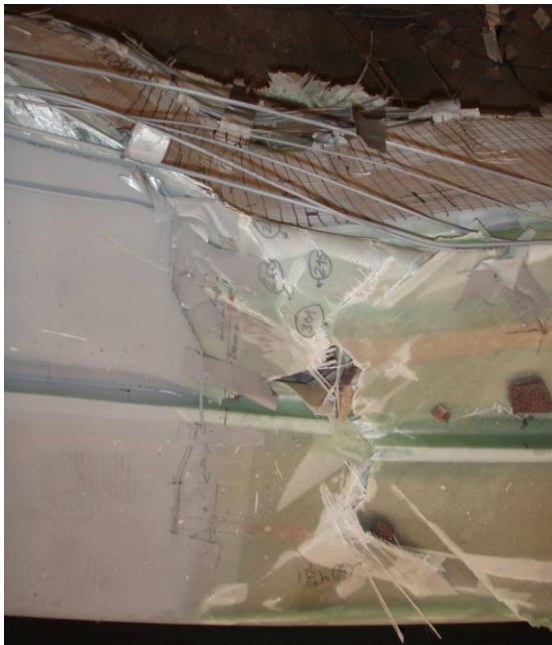
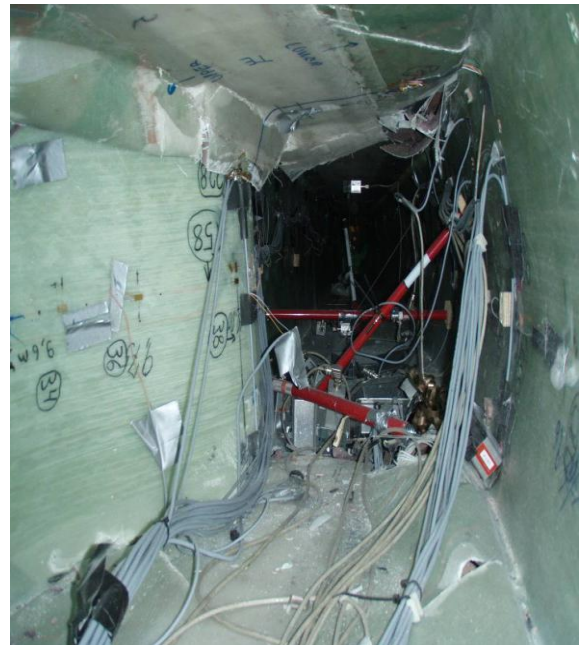
Figure 43. Failure: Box girder 1 collapsed.

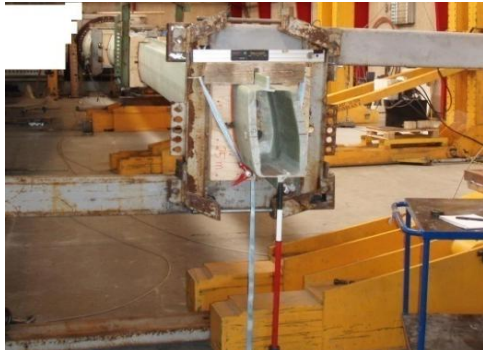
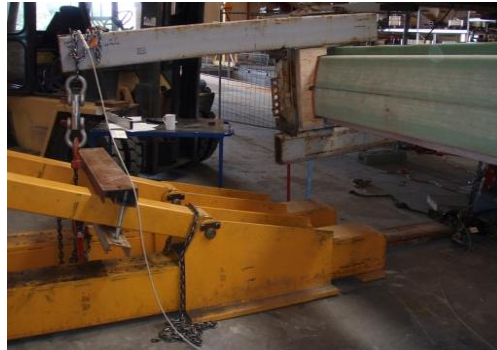
Figure 44. a: The torsional test set up in CCW direction. b: Close up of the outer) loading clamp. b: Close up of loading setup seen from behind, the bending moment applied CW.

The torsion test was carried out with a confidential load. The box girder was mounted on the test rig, as it was done under the flapwise bending test. However it was not supported in the same way. This is presented in Figure 44a.

Sketch in figure 44 illustrates the test setup.

The test was performed with a counter-clockwise (CCW) and clockwise (CW) torsional moment. The definition of the counter-clockwise direction is shown in Figure 44 looking from the tip towards the root.

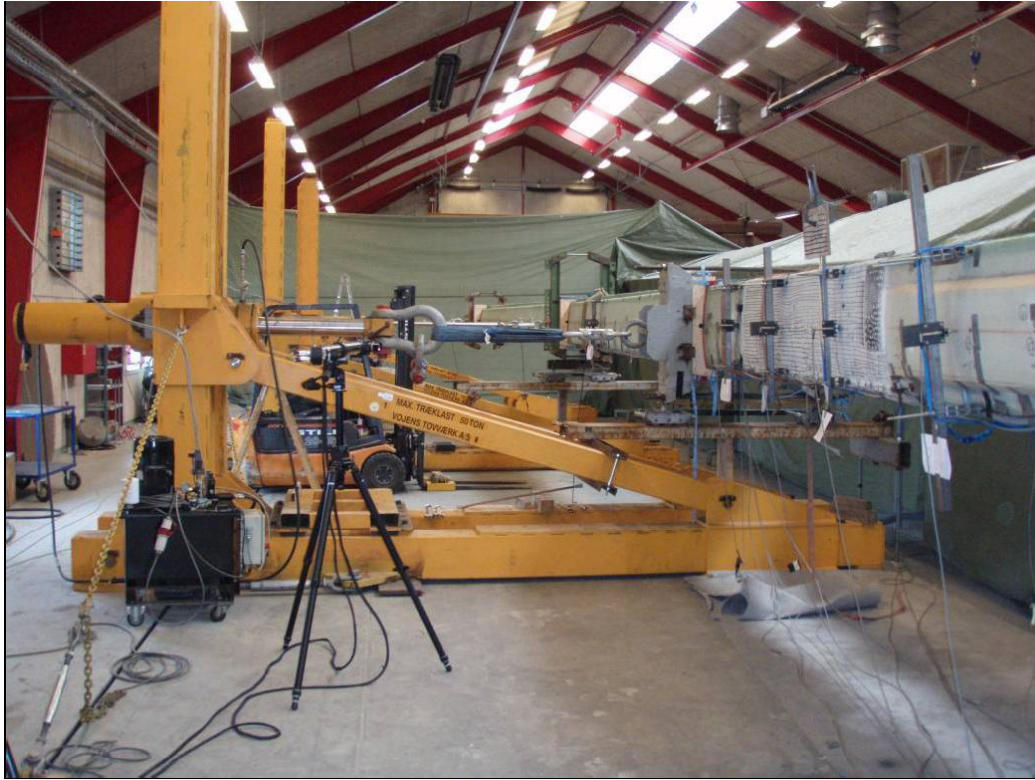
Figure 49. ARAMIS equipment (facing towards the tip).

Aramis is an optical measurement system which can measure deflection in three directions at the same time. The system uses two cameras detecting the difference in measured pattern. This technique can measure the deflection in an area of 2.5m by 2.5m for a four Mega pixel system.

In principle the ARAMIS system works by analysis of the acquired images. Undeformed stage is used as a reference and multiple deformed stages are recorded during a test.

Multiple subsets of image pixels are analyzed by a grey-value correlation technique in the undeformed and the deformed state.

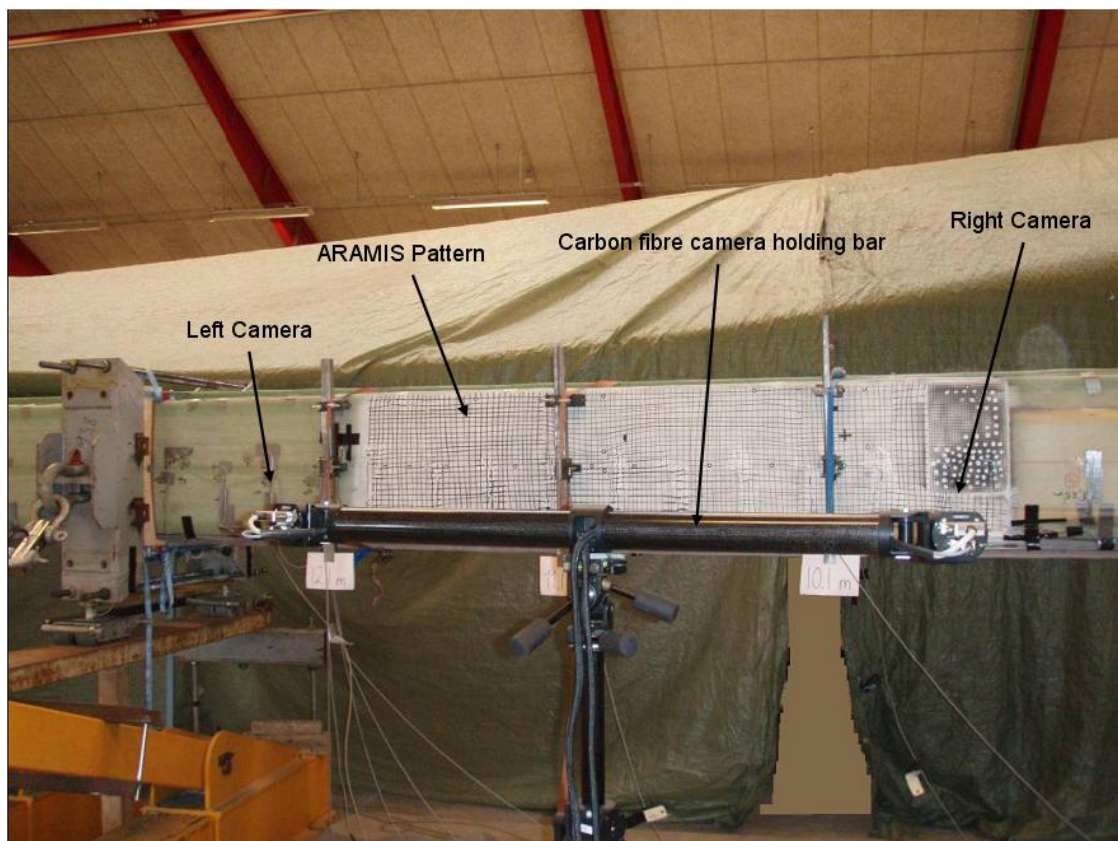
In the Figure 50 the measuring equipment is shown from behind, facing the compression side of the box girder. Note the painted speckle/ random pattern on the box girder compression side.

Figure 50. ARAMIS equipment positioned in front of the measuring area.

The ARAMIS performed measurements on the box girder's compression side in the distance of 9 to 12 meters from the root. The results from these measurements are presented in the following figure.

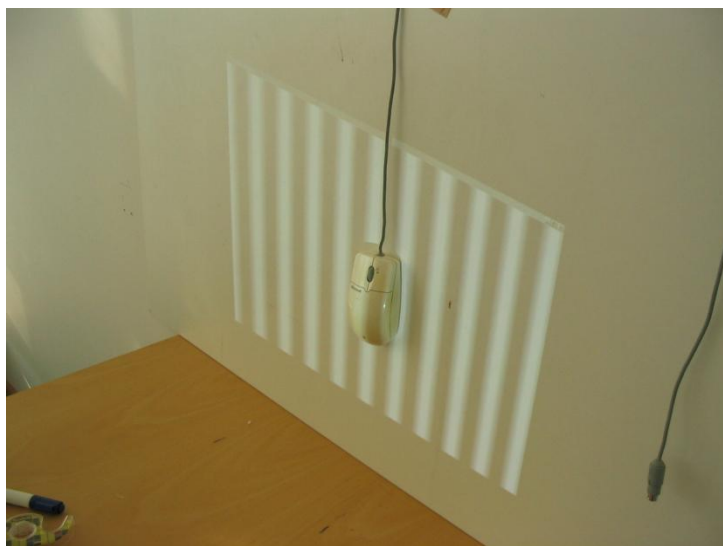
Figure 55. The surface of interest is illuminated by a cosine intensity pattern. For illustration, a computer mouse is inserted as an object in the fringe pattern.

The fringe projection technique is a non-contact optical method for measuring out-of-plane surface deflections of whole 2D-surfaces. The system is based on a multi-channel triangulation technique, where the surface of interest is illuminated by a fringe pattern consisting of straight stripes with a cosine intensity variation, see Figure 55.

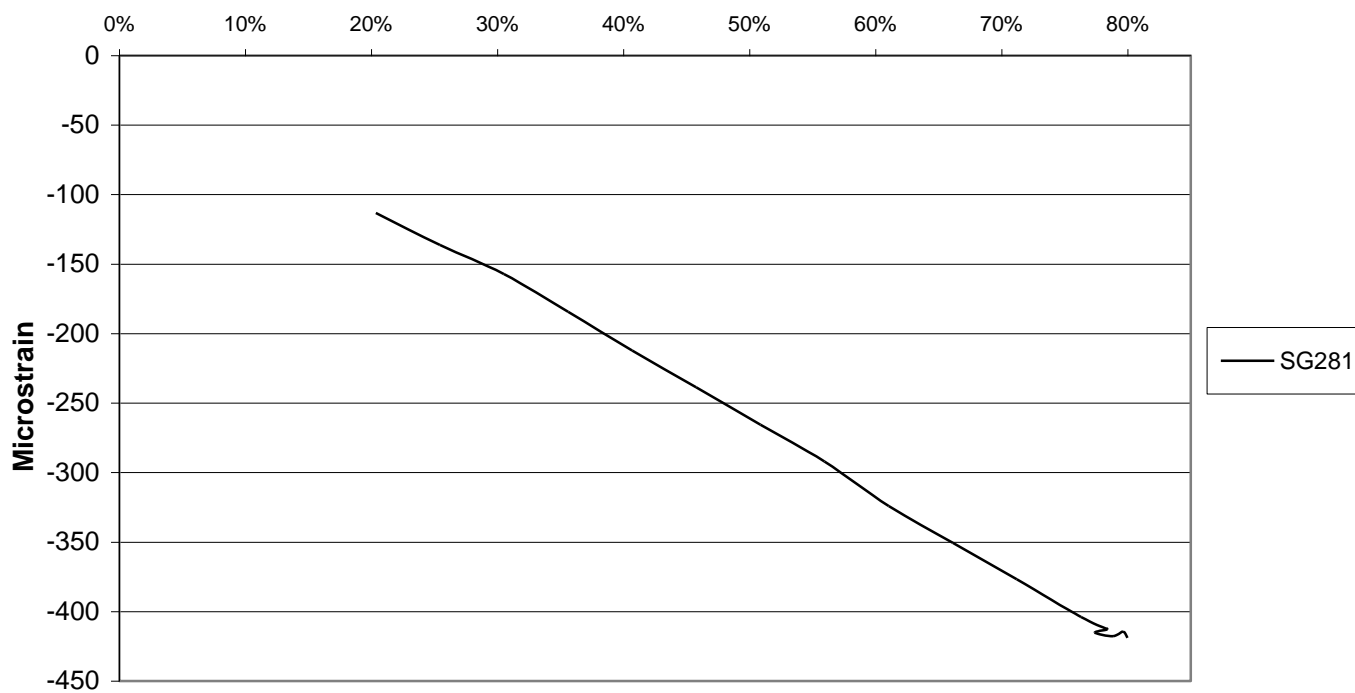
45° Strain gauges on Trailing web towards tension side measured at midpoint in 15m
